Project Brief

Kaiwharawhara Rail Bridge 3NL Bridge Plinths

Wellington, NZ
2005

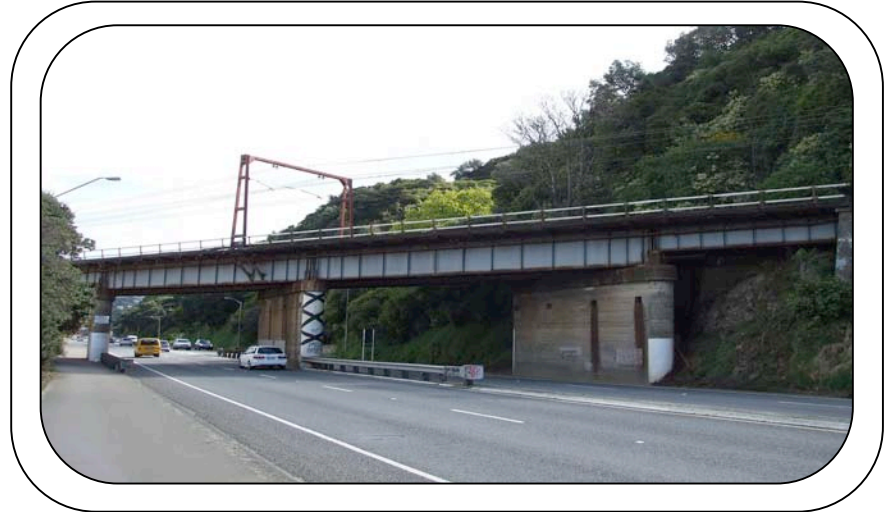
Abutment creep was causing higher loading of the bridge plinths on top of the piers. The plinths were cracked and required repair and confinement. Significant corrosion staining and concrete spalling was evident. The no obligation, free Fyfe design service provided steel equivalency calculations and One layer of Tyfo® SCH 41 carbon composite 610mm wide flush with the top face of the plinth with a second layer 305mm wide at the top (flush with the plinth) was installed.

The top 2 photos for this reference were taken in 2010 (5 years later) and the plinths appeared in the same condition as immediately after the retrofit.

This specification provided more tensile force than provided by 2x 25mm Dia grade 500 RediBars. The strength is distributed over the full height of the plinth and the materials are low profile and non-corrosive. Vertical RediBars were installed for block shear and overturning forces.
