Project Brief

Ruahine Street Over-Bridge Timber Laminate Repairs

Wellington, NZ
2008

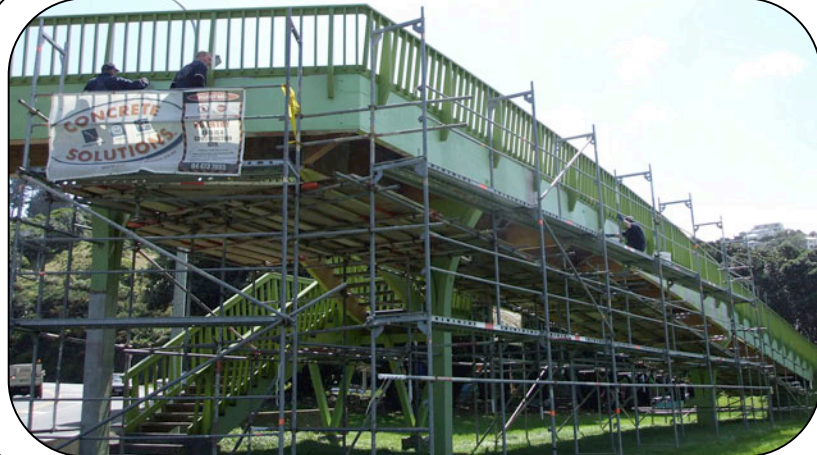
The laminated timber beams of the bridge were failing at the glue lines and subsequently further damaged due to water ingress.

The delaminated beams on the bridge ramp were repaired with Tyfo® SEH 51A composite, applied in a U wrap and anchored together at the top of the beam to provide confinement. The Beam was then drilled through all the laminates at 300mm centre's up through the bottom, and injected with MC-Injekt 1264 at 1500psi.

With the bridge beam's glued back together, confined and all cracks and gaps filled, the repair areas were then painted to match the existing colour scheme.
