## Gear Island WTP

### Water Tank Strengthening

Wellington, NZ  
2006

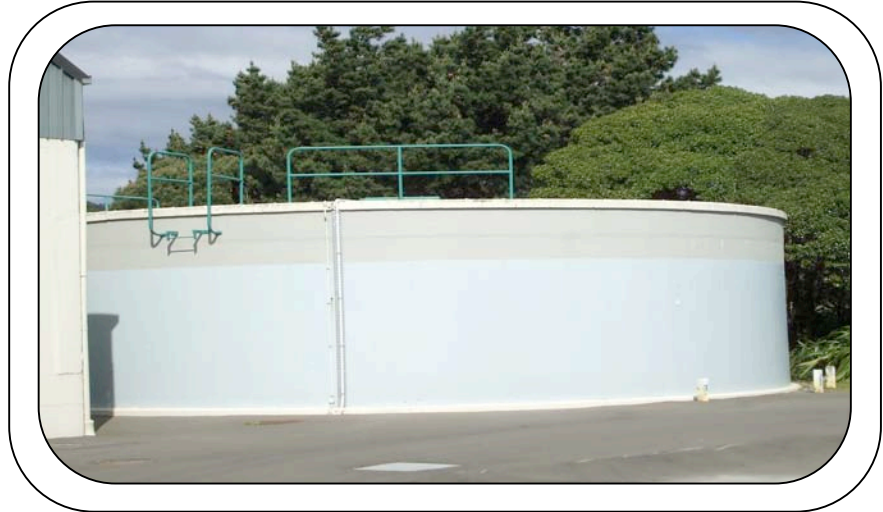
Under the effects of seismic activity, the top of the tank was capable of separating from the tank walls with significant differential deflection, requiring urgent remedial attention.

The solution called for a two pronged approach; Starter bars were drilled through the top down into the walls and grouted.

Five layers of Tyfo SEH® 51A was applied in a band around the top of the tank walls to provide confinement and prevent flexing. The Tyfo® was painted with Tyfo® A Acrylic Finish Coat to protect the Fibrwrap from UV and blend the retrofit area to the rest of the tank.
