Project Brief

Kohinui Bridge P37 Abutment Strengthening

Kohinui, NZ
2002

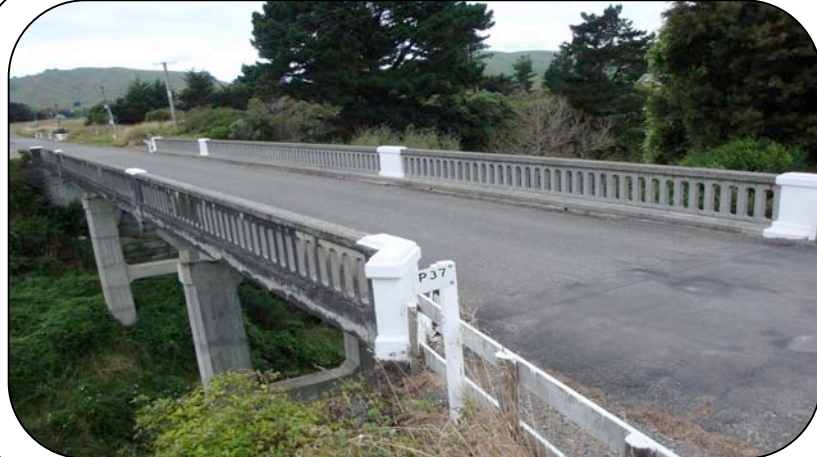
The abutments of this bridge required strengthening due to creep. New piles were installed and Fibrwrap was specified to tie the new piles into the existing abutment.

This detail involved cutting a slot in the abutment and feeding the Tyfo® SHE 51A Fibrwrap through to provide the necessary confinement.

Steel Starters were drilled through and grouted in-place.

An added benefit of the Fibrwrap was the added corrosion protection to an area of particularly high steel concentration with the possibility of low concrete cover.

The Fibrwrap was painted over with Tyfo® A Finish coat to blend the installation to the colour of the surrounding structure and provide UV protection.
