Project Brief

Rush Creek Foot-bridge Deck Strengthening

West Harbour, Auckland
2008

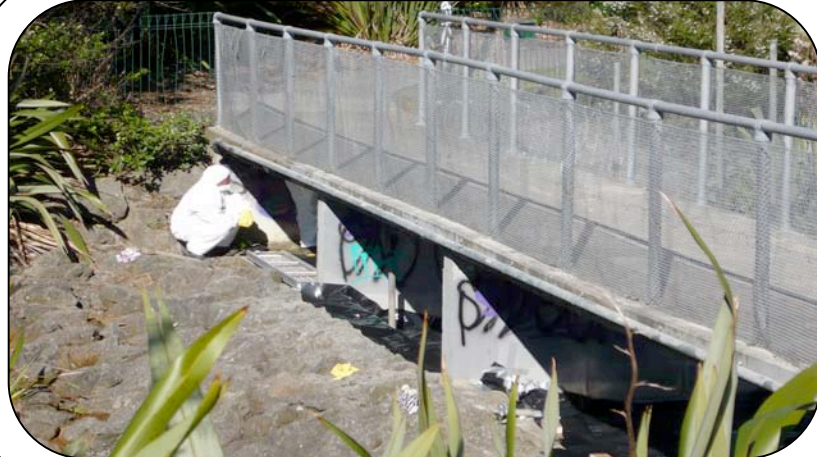
A construction error caused the bridge deck to exceed allowable deflection.

The successful solution utilized the Tyfo® 2UC55 Composite Laminate Strip System which was unobtrusively retrofitted to the underside of the bridge deck.
