Project Brief

# Rankine Brown Building

## Structural Upgrade

Wellington, NZ  
2003

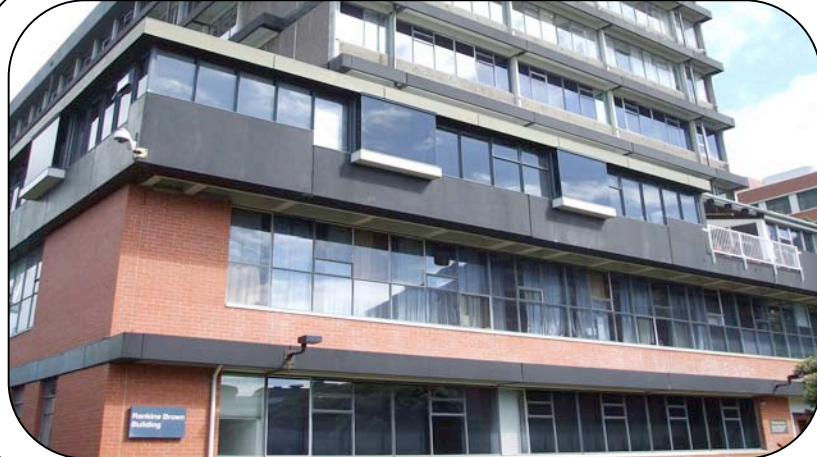
The existing secondary columns on the perimeter of level 0 and 1 required strengthening and the installation of a revised pinned connection detail at the top and bottom of the columns. The columns were saw cut to reveal the steel Tentor Bars which were wrapped with 2 x layers of polythene tape (bond breaker) and 5 x layers of Tyfo® SCH 35 carbon composite.

The columns were wrapped full height with 3 x continuous layers of Tyfo® SEH 51 glass composite with a 150mm of finish edge from start edge. The wrap was specified to start/finish symmetrically about the centerline of the column face.
