Project Brief

National Bank Floor Strengthening

Wellington, NZ
2009

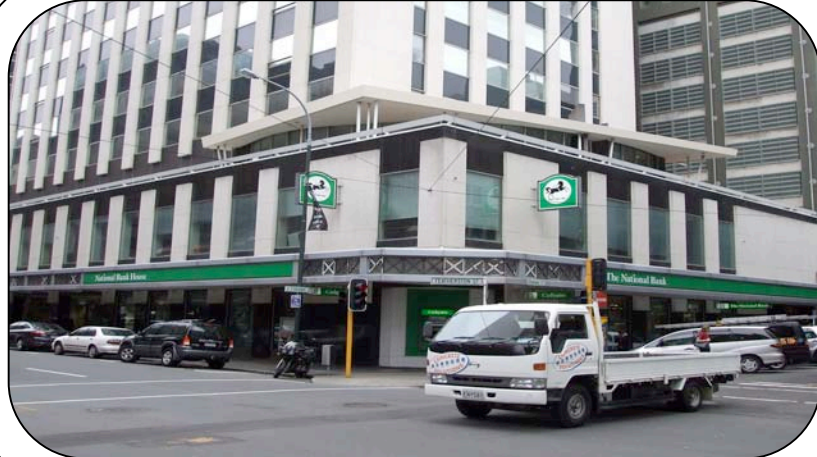
The National Bank required a new storage system to be installed, significantly increasing the dead load on a floor. This floor was badly cracked and had recently had new penetrations for services.

The successful solution called for a combination of Tyfo® Web Composite and Tyfo SEH 1/4"(6.4mm Dia)x6"(152.4mm) Composite Anchors.

The work area was tented off and a dust filtering extract system used to minimize any inconvenience to users of the car park below the floor being strengthened. The mechanical prep including removal of finishing plaster, grinding the concrete surface and drilling the anchors for the composite anchors was completed outside normal work hours do minimize noise disruption to the tenants of the space above.

The FYFE patented standard glass anchors were installed at 300mm centres with 75mm embedment and 75mm splay.
