Project Brief

Police National HQ Floor Strengthening

Wellington, NZ
2009

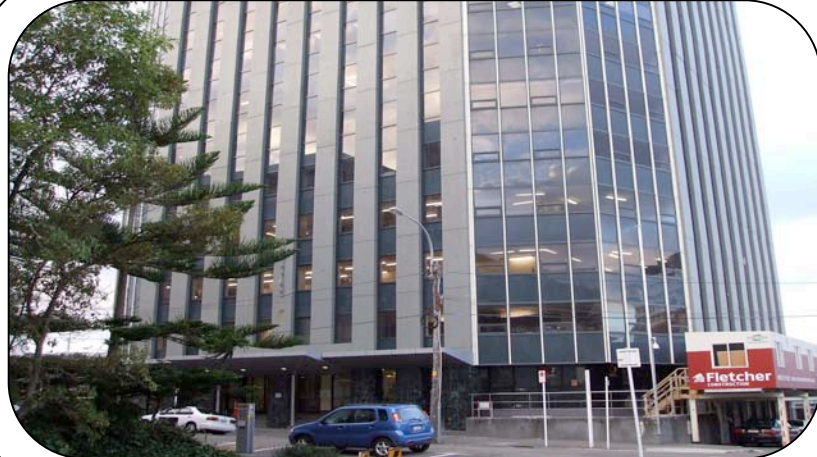
Strengthened areas included reinforced concrete beams and spans of Diamond HiBond flooring system which were retrofitted unobtrusively, after first conducting pull-off testing to confirm the bond strength of the Tyfo® S Epoxy to the galvanized surface.

It was an important benefit of the Tyfo® system that it wouldn't require additional material to compensate for the loss of the HiBond structural integrity. The Tyfo® 2UC55 Strip was installed directly onto the existing HiBond without any cutting or compromise of the HiBond.
