Project Brief

Trinity Hotel

Column & Floor Strengthening

Wellington NZ
2003

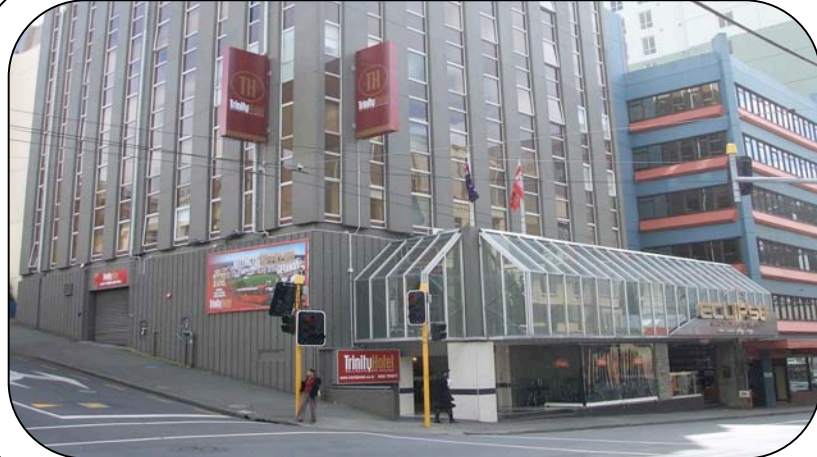
During alterations, penetrations were cut into the existing floor diaphragm. The slab around these penetrations was strengthened with strips of Tyfo® SCH 41 to the underside of the slab. The strips of fabric allowed easy lapping with perpendicular strips and less development length required relative to Pultruded strip (due to the extra width).

The seismic upgrade to the columns involved the installation of vertical steel bars. The flexural loads were developed by passing steel through the floor slabs and welding it back onto the new column steel. The steel on the columns was then confined by wrapping with Tyfo® SCH 41.
