Project Brief

Hospital Water Reservoir

Strengthening and leak repair

Wellington, NZ
2009

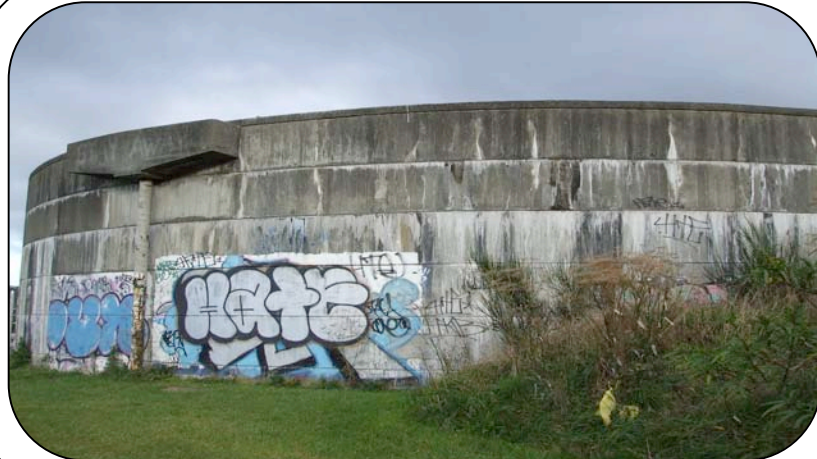
The tank is constructed from several precast rings sealed together onsite. The tank was leaking and the remedial solution called for a potable water safe repair system.

Tyfo® Web composite was installed in horizontal bands over the joints to seal and reinforce the joint. Tyfo WP Wet Prime Epoxy was used as the primer to the damp substrate.

The Tyfo Web reinforcing fabric is a custom 0°/90° bi-directional weave. The glass fiber is orientated in both the 0° and 90° direction in optimum configuration for this application.
