Project Brief

Quest Building Shear Walls

New Plymouth, NZ
2008

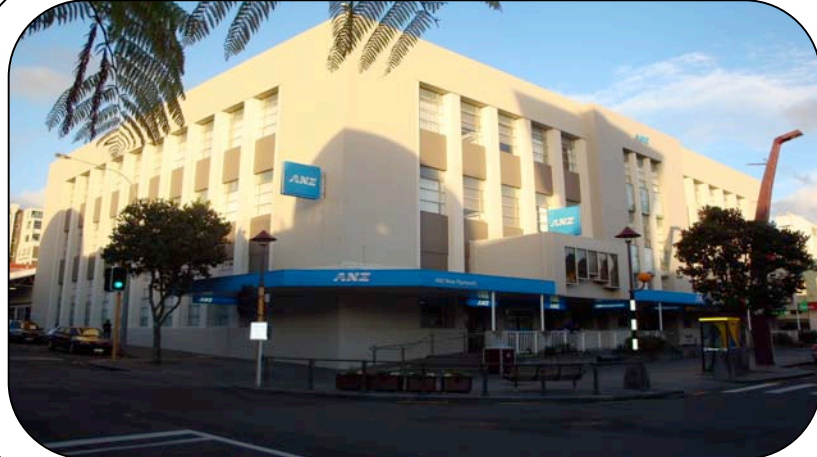
This building required strengthening, Tyfo® 4UC55 Composite Strips were installed vertically to address a deficiency in the original lapping of the vertical bars and Tyfo SCH 41 was installed over these in the horizontal direction to provide shear reinforcement.

The building façade also required crack injection with MC 1264 injection resin and concrete repair with the MC Zentrifix KMH and Nafufill KM250.

The substrate prep was completed by a specialist, local demolition and preparation company who understand the level of prep required for the installation of the Tyfo® systems.
